Manhole Inspection Summary

Manhole # S23M__012MH

Location Address: **418 S Calhoun St**

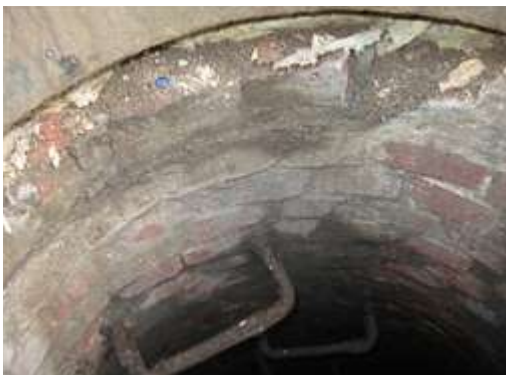
Defect 6

Condition: ☐ Sound ☐ Cracked ☒ **Leaks**

Condition: ☐ Sound ☐ Cracked ☐ Root Intrusion ☒ **Loose Brick** ☐ Deteriorated

Infiltration: ☐ None ☒ **Joint** ☐ Cracks ☒ **Mortar** ☐ Roots ☐ Wall

frame-chimney joint infiltration, loose bricks in chimney

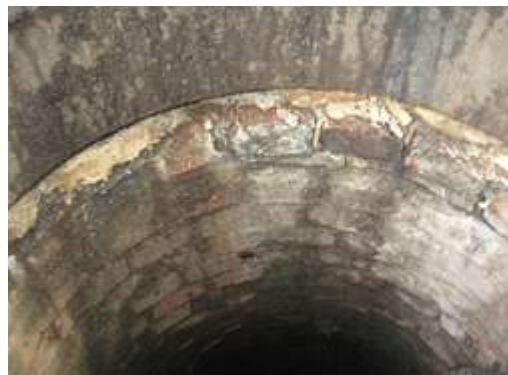
Defect 5

Infiltration: ☐ None ☐ Joint ☐ Cracks ☐ Mortar ☐ Roots ☒ **Wall**

lid-frame infiltration, corbel infiltration

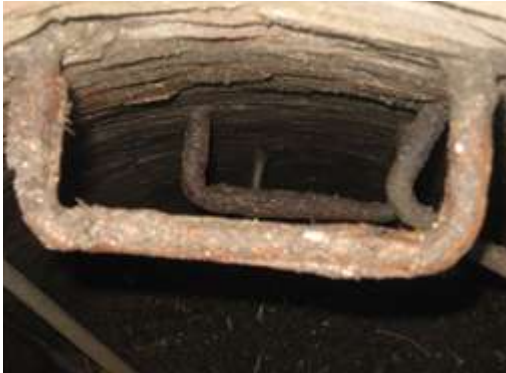
Defect 4

Count: **6** Missing: **0** ☒ **Corroded**

corroded rung

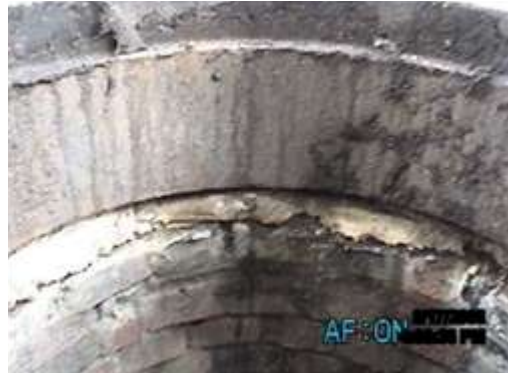
Defect 3

chimney infiltration

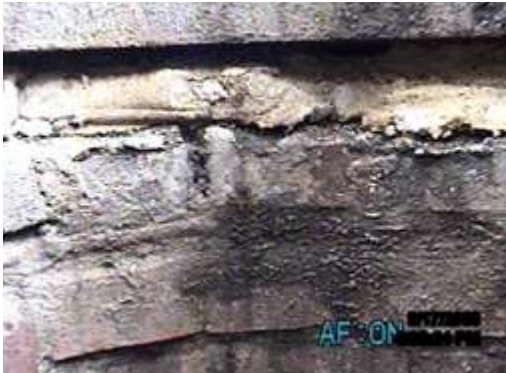
Defect 2

infiltration frame-chimney connect

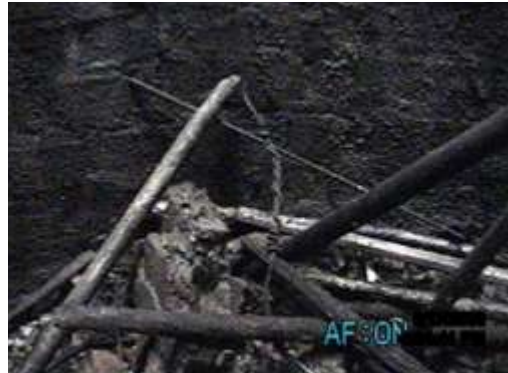
Defect 1

Condition: ☐ Sound ☐ Cracked ☐ Root Intrusion ☐ Deteriorated ☐ Leaks ☒ **Debris**

debris in channel

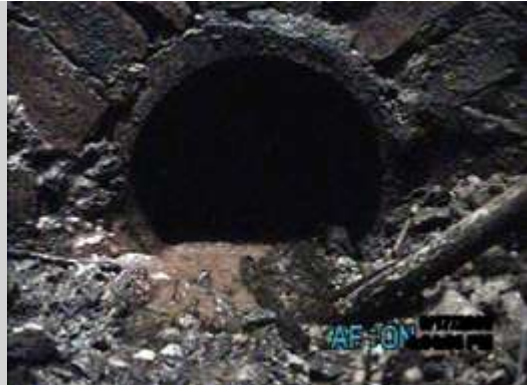
12 O'Clock Outflow

6 in. Circular Gravity Sewer
Pipe Out @ 12 O'Clock

Infiltration: **None** Pipe Seal Cond: **Sound**
